# **Intel® 450NX PCIset Specification Update**

Release Date: February 1999

Order Number: 243848-008

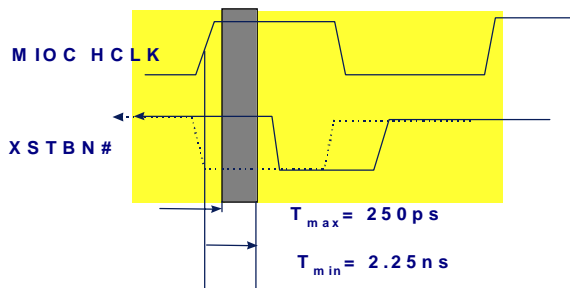
**Figure 2. Timing Window Where Strobe Falling Edge Must Be Avoided**

**WORKAROUND:** The failure band is narrow enough that slightly varying XSTBN# falling-edge arrival with respect to MIOC's data-output timing can prevent the failure from occurring. Delaying XnCLK from the MIOC to the PXB can vary this timing and can be accomplished by adding extra loading or trace-routing to the XnCLK signal routing (if adjusting the entire F16-bus routing is not feasible due to existing board layout). To assist in designing board layout for avoidance of this problem, consider calculating the sum of the following system timing parameters and comparing against the limits of the failure band or timing "window."

Implementing this workaround may require deviating from the clock-skew specification. The skew between XpClkFB at the MIOC and XpCLK at the PXB may need to increase to account for a delay to the XpCLK line. Note that due to min/ max parameter variances, it may not be possible to design a workaround which can guarantee avoidance of the failing timing scenario, at least not without violating other timings. If this is the case, calculating the above timing and comparing min/ typ/ max values may still provide some assistance in designing a system workaround which could minimize exposure to this problem.
